Failure Analysis of an AH-64 Main Rotor Damper Blade Rod End, P/N 7-211411186-5

ARL-TR-3100

December 2003

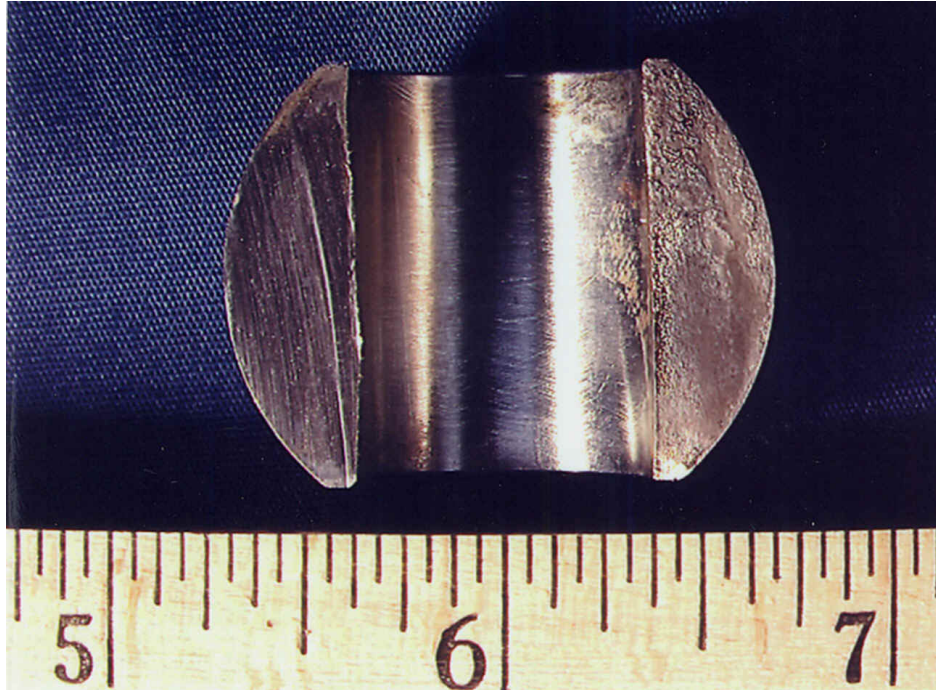
Figure 5 shows half “B,” which remained in the as-received condition for further analysis (see SEM/EDS section 9).

Figure 5. Fracture half “B,” left in the as-received condition (scale in inches).

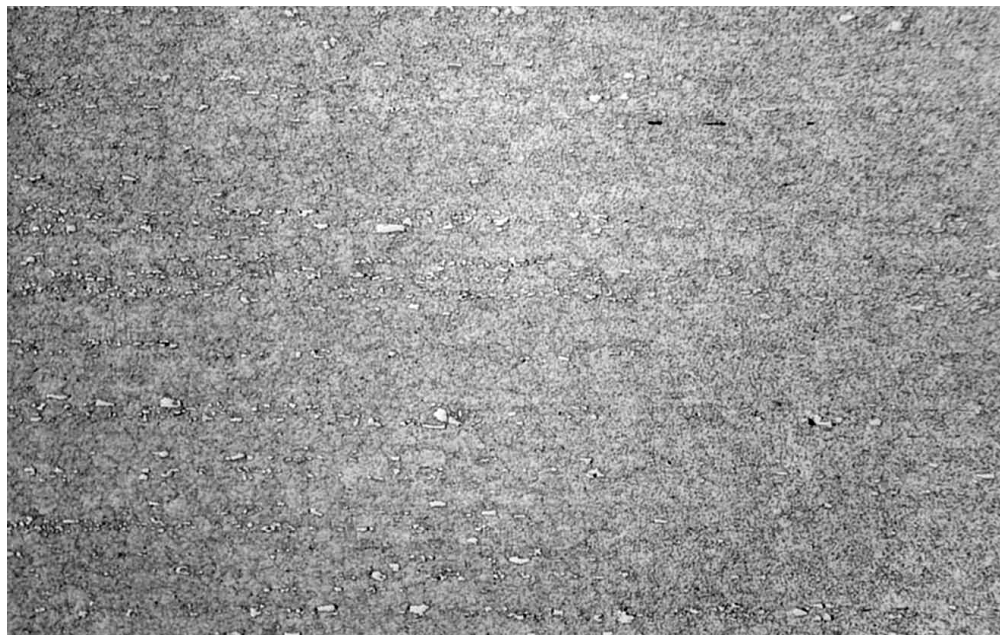
The samples were subsequently etched with Vilella's reagent to reveal the microstructural features. At low magnification, some banding was noted, indicative of the prior flow direction (see figure 23) in the material.

Figure 23. Etched microstructure of the ball material showing the presence of banding (mag 100x).

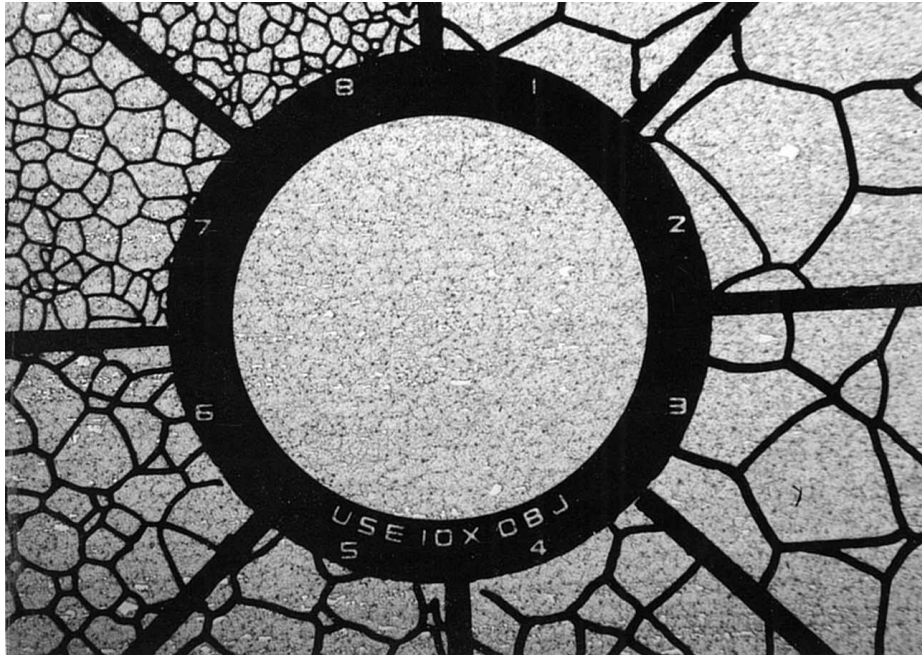
The grain size of the material was determined to be 8 or finer with the reticle overlay shown in figure 24. The regions of inter-granular attack were observed after the etchant was applied. Figures 25 through 30 correspond to the respective regions depicted in figures 17 through 22. The inter-granular nature of the attack became enhanced upon etching.

Figure 24. Etched microstructure demonstrating the grain size to be 8 or finer (mag 100x).

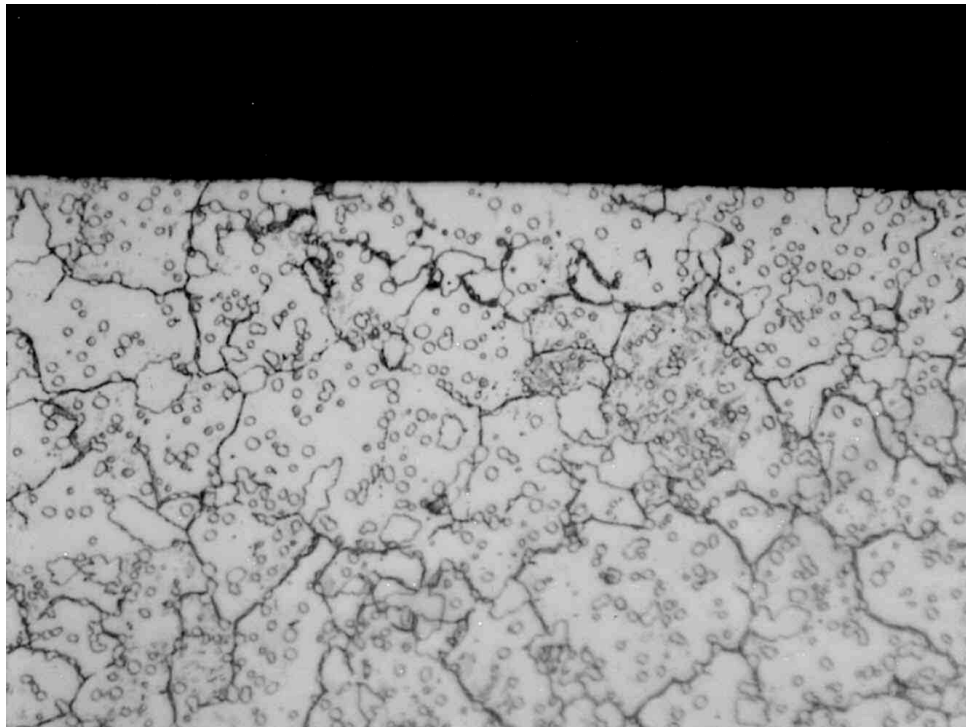
Figure 25. Etched transverse metallographic section area "A," (mag. 1kx).

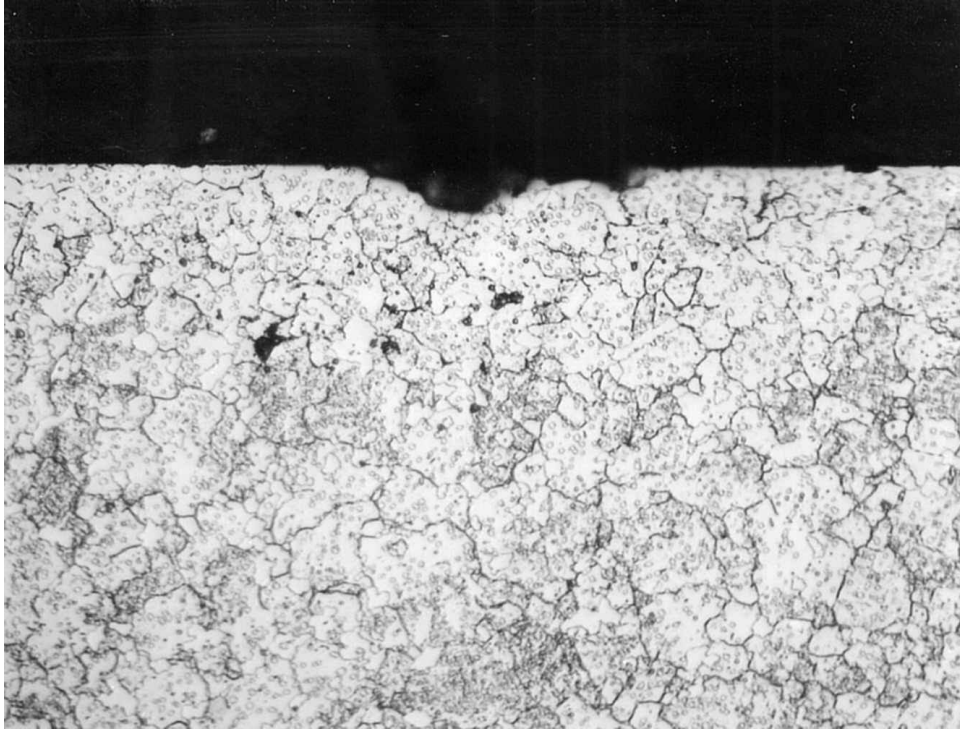
Figure 26. Etched transverse metallographic section area “B,” (mag 500x).

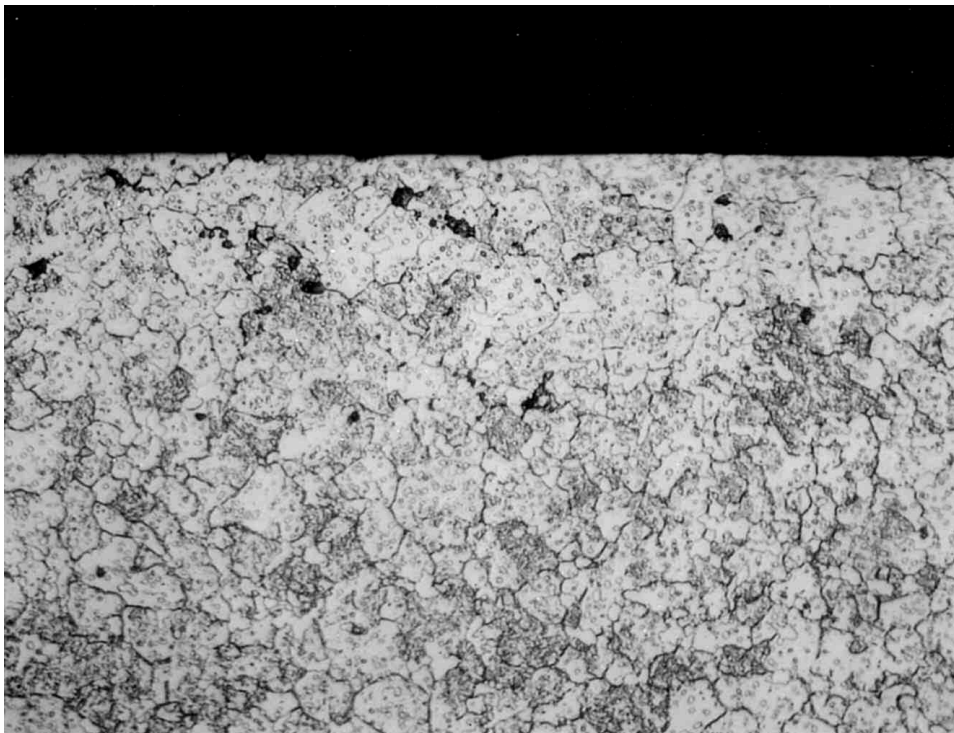
Figure 27. Etched transverse metallographic section area “C,” (mag 500x).

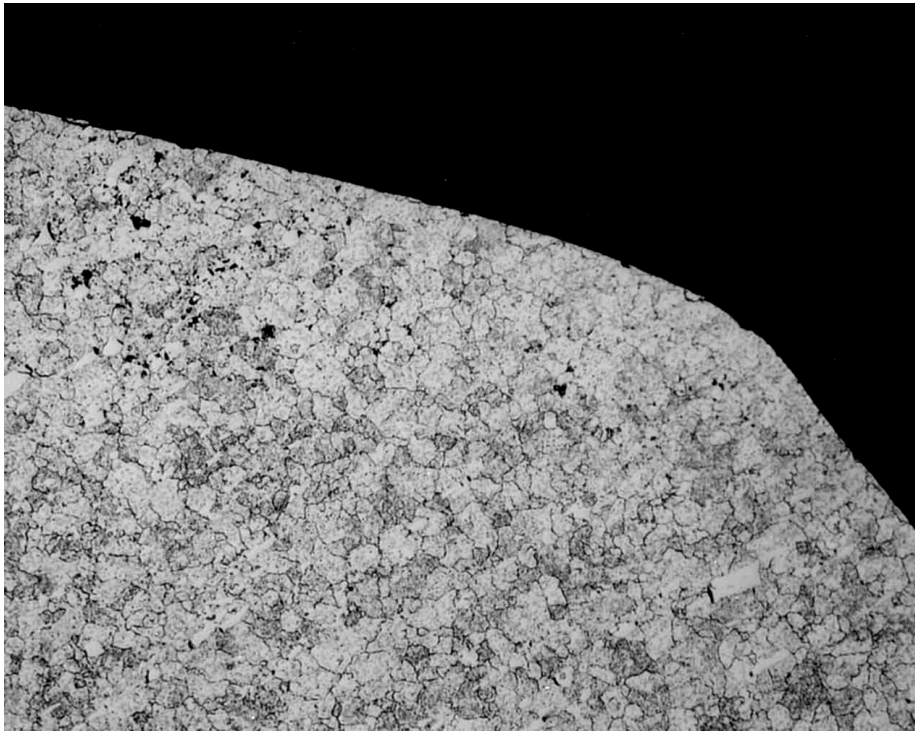
Figure 28. Etched longitudinal metallographic section area “A,” (mag 200x).

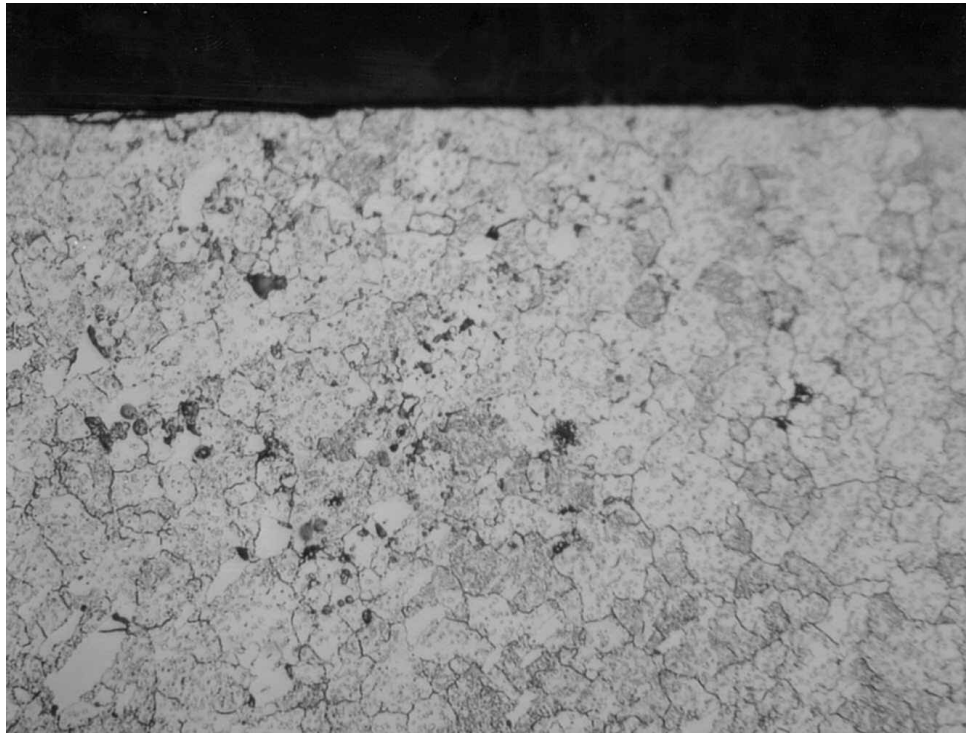
Figure 30. Etched longitudinal metallographic section area "C," (mag 400x).

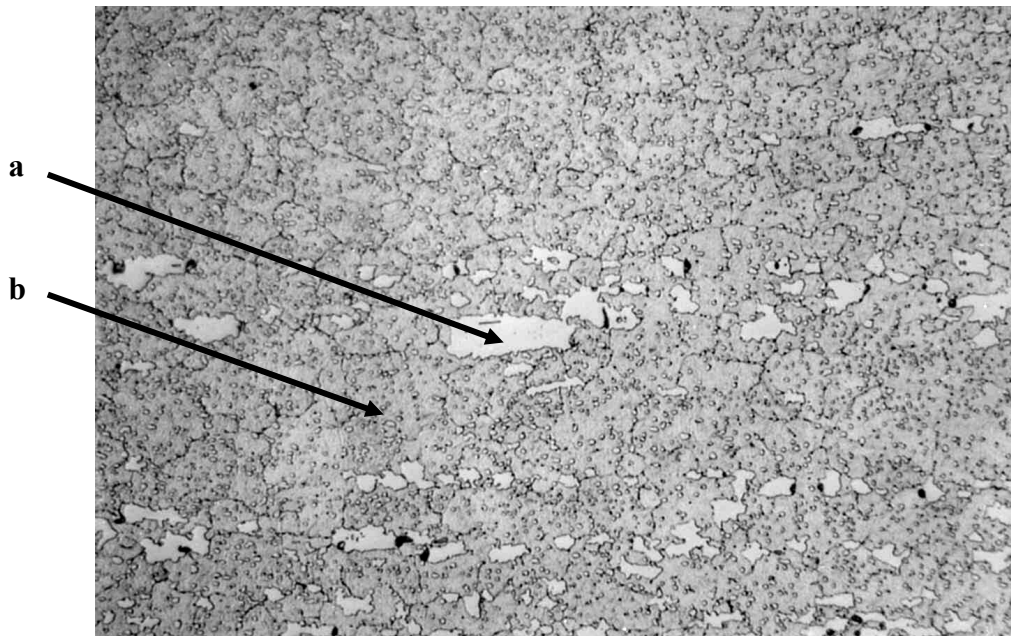
The microstructure was subsequently observed at 500x and 1000x magnification (see figures 31 and 32, respectively). The structure consisted of primary M_7C_3 carbides (figures 31a and 32a) and secondary carbides (small spheroidal particles shown in figures 31b and 32b) in a matrix of tempered martensite. Note, however, that Vilella's reagent does not reveal the tempered martensitic structure in this material as it appears in other common steels. The lathe-like structure is noticeably obscured. The primary carbides ranged in size, measuring as long as 0.0012 inch (30 μm). This size was well within the nominal size (as long as 60 μm) to be expected for this alloy. The structure was typical of type 440C stainless steel that has been austenitized, quenched, and tempered.

Figure 31. Etched longitudinal microstructure of 440C ball (mag 500x).

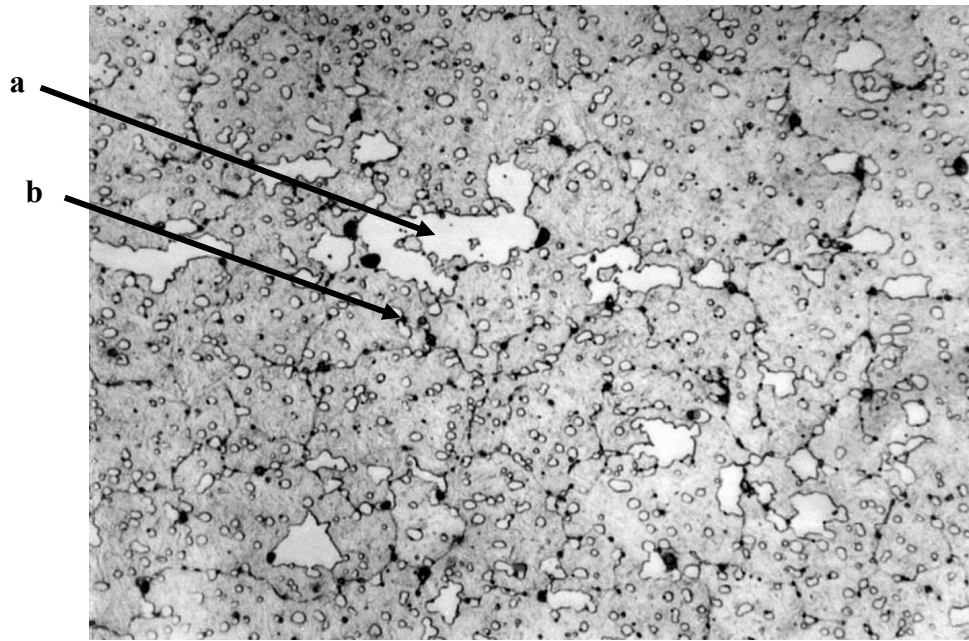
Figure 32. Etched longitudinal microstructure of 440C ball (mag 1kx).

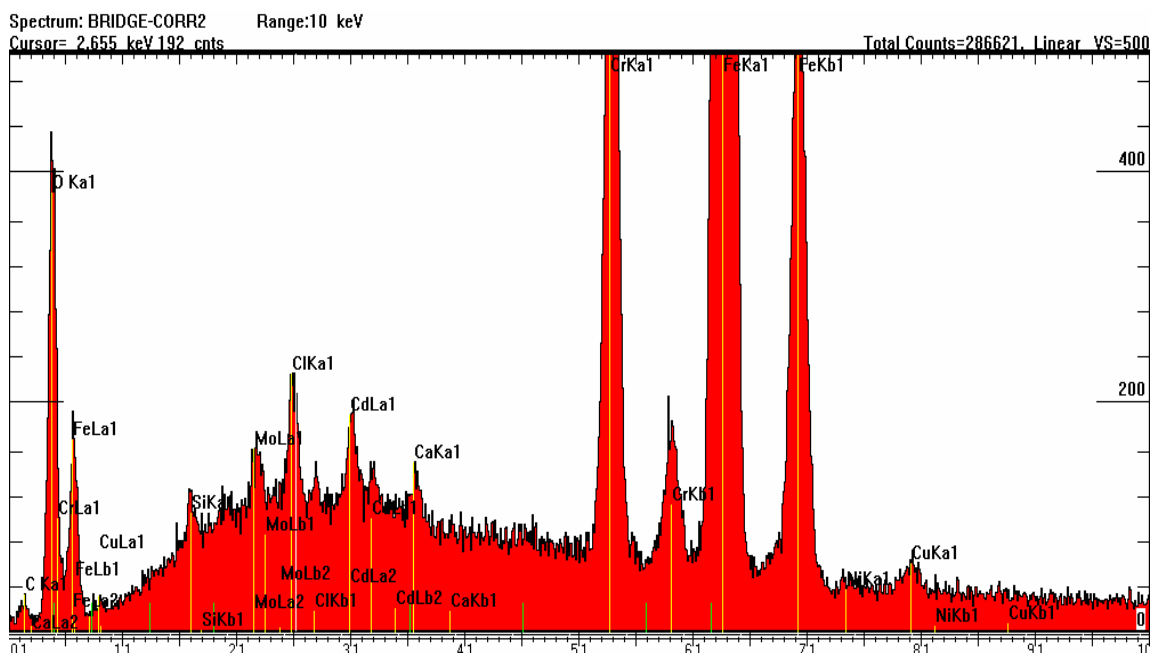
The attacked area was filled with corrosion product. This product was analyzed with EDS. The EDS spectrum produced from this product can be observed in figure 37. It was similar in chemistry and composition to the other attacked areas on the ball. However, it was slightly different from the corrosion product on the fracture surface that is presented later.

Figure 37. EDS spectrum collected from the product within the inter-granular attack.

Naturally occurring chloride salts can explain the presence of calcium and chlorine. The copper, nickel, and molybdenum are alloying elements within the material, so it is understandable that they are revealed within the corrosion product. The cadmium, however, must have originated from a foreign source to this ball. This is discussed in more depth later.

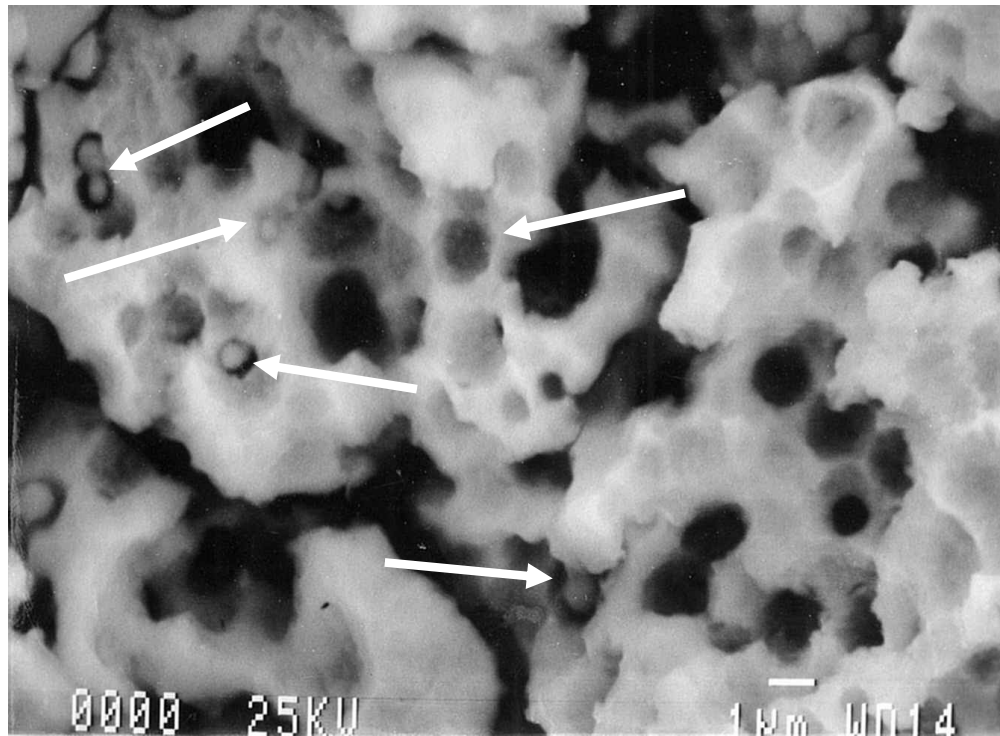
attacked. Conversely, they are dislodged by the attack. Figure 40 depicts this region. The depletion of chromium in the regions surrounding the precipitates makes this occurrence intuitive. The white arrows indicate the precipitates in advancing stages of dislodgment. Figure 41 presents the precipitates shown in figure 40 at higher magnification. Other inter-granular attacked areas demonstrated evidence leading to this conclusion.

Figure 41. High magnification showing detail of figure 40 (mag. 5kx).

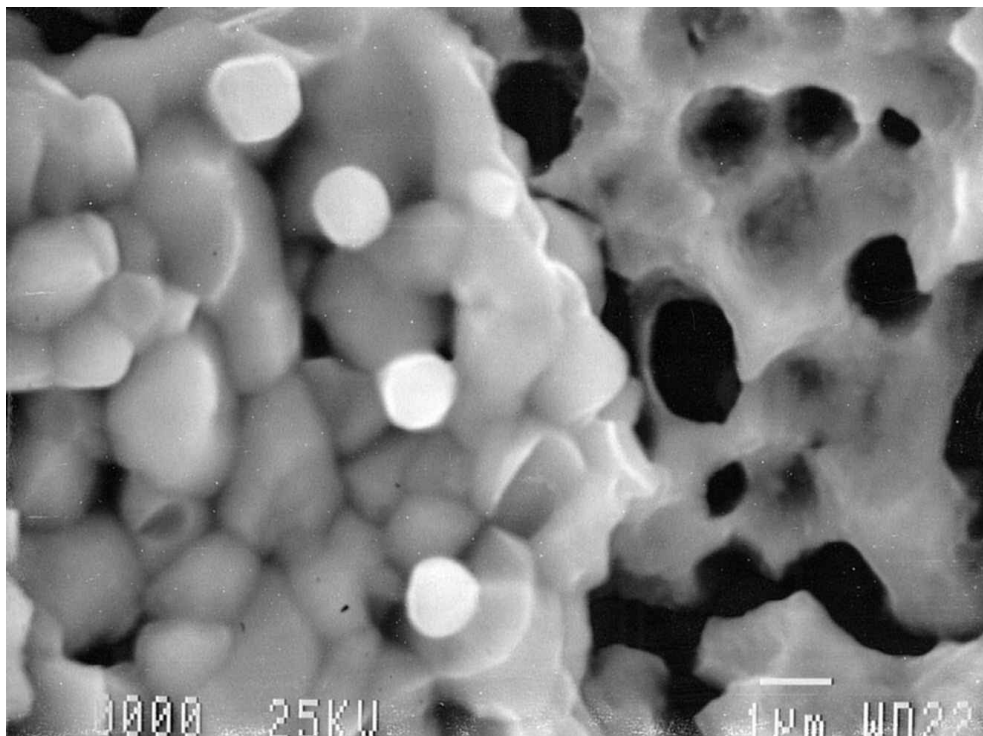
Figure 44. Four distinct dislodged precipitates (mag. 7500x).

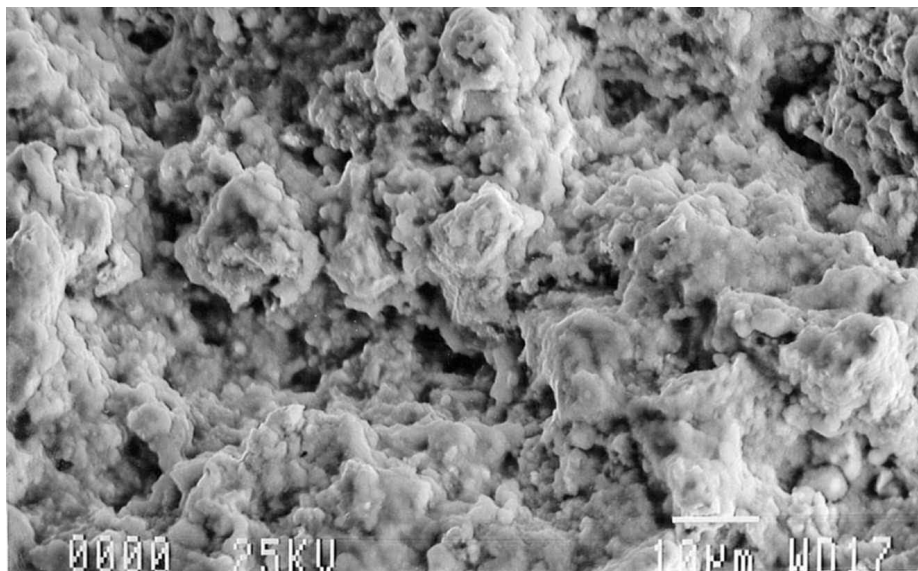
The fracture surface did not add considerable significant information to that which was concluded from the surface of the ball. Five fractographs were taken evenly spaced across the fracture surface to identify differences as the fracture progressed. The fracture mode, however, was mixed transgranular favored by fatigue and inter-granular favored by corrosion. These fractographs are presented in figures 48 through 52, from the origin. Within these fractographs, it is discernible that the fracture progressed in a mixed mode (trans-granular/inter-granular), aided by alternating stresses and corrosive action. The preferential cracking around the precipitates is readily discernible since several precipitates and cavities are easily recognized. The severity of the corrosion increased with age, toward the origin, as would be expected. The fracture was notably

Figure 48. Fractograph 1 of 5, nearest the origin (mag. 1kx).

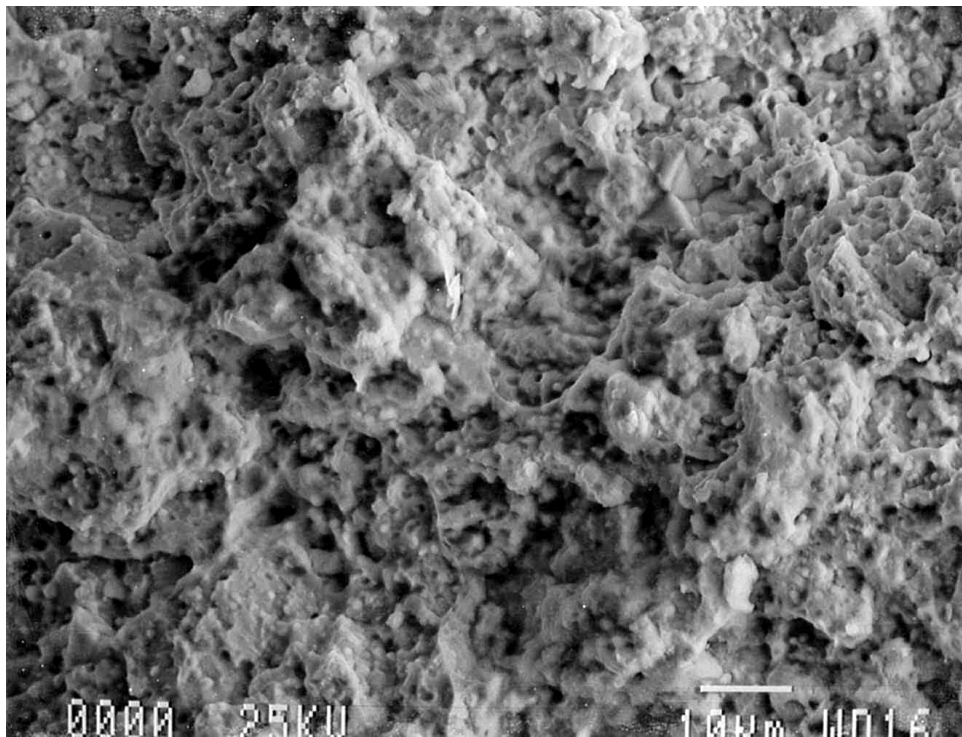
Figure 50. Fractograph 3 of 5, at the midpoint of fracture (mag. 1kx).

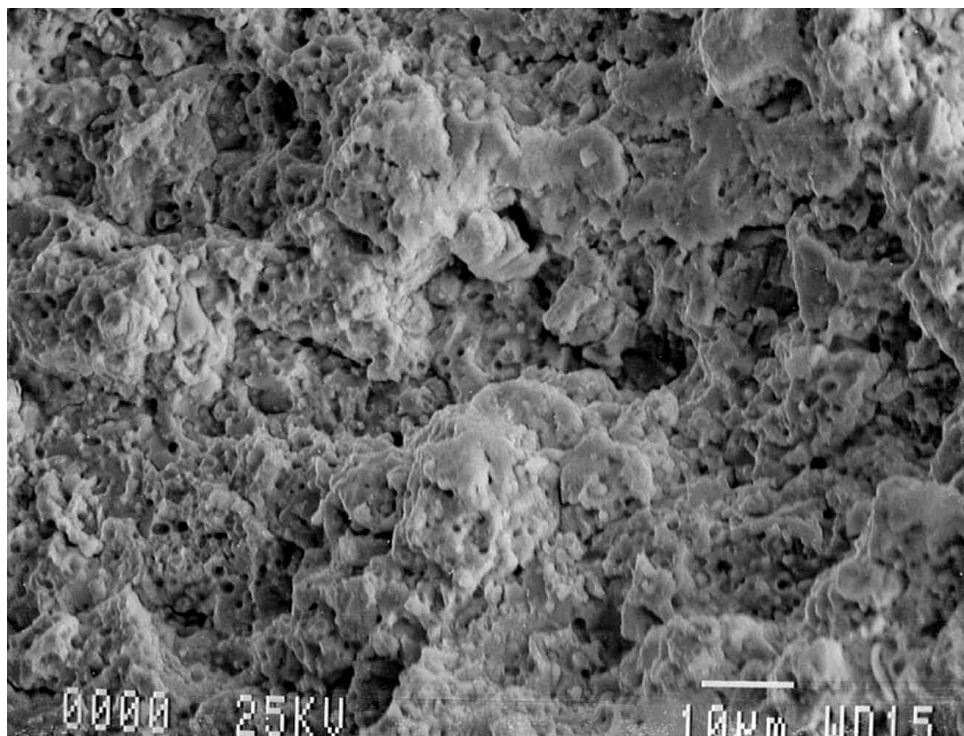
Figure 51. Fractograph 4 of 5, showing only light corrosion (mag. 1kx).

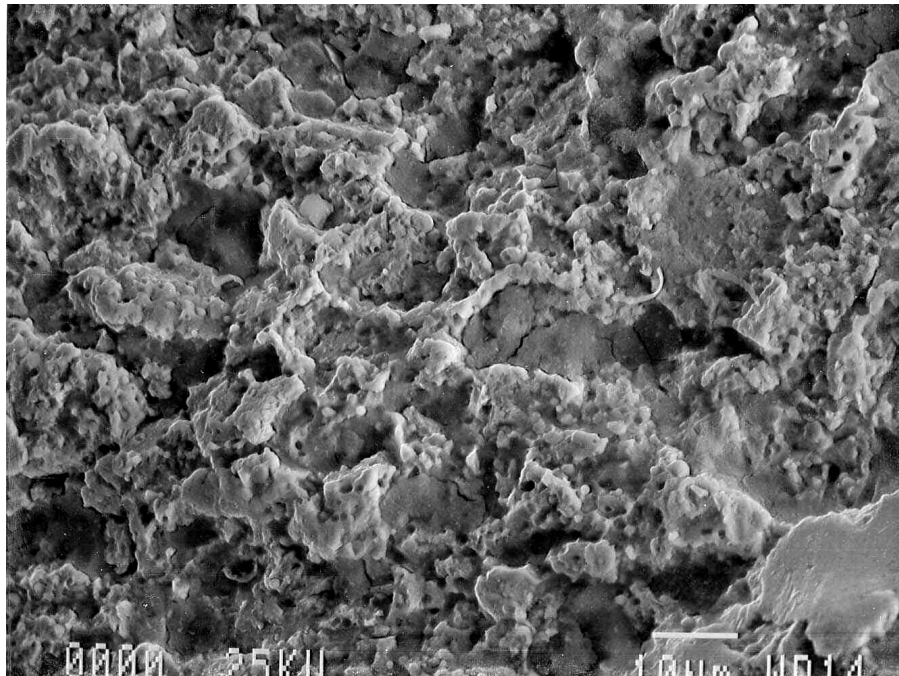
Figure 52. Fractograph 5 of 5, farthest from the origin (mag. 1kx).

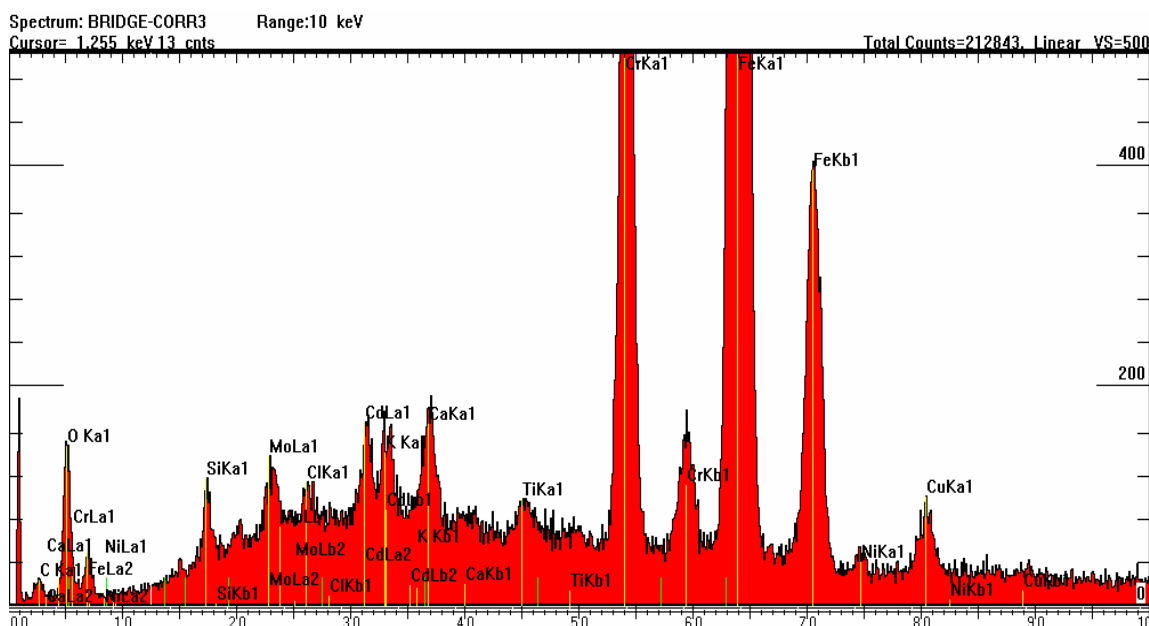
The corrosion observed coupled with the fact that noticeable fatigue beach marks were discernible, would lend evidence to corrosion fatigue being the failure mechanism. EDS analysis of the corrosion products on the surface proved slightly different from the corrosion products observed on the surface of the ball. Figure 53 presents the EDS spectrum of the corrosion products on the fracture surface. Table 17 presents the chemical analysis data acquired from that EDS spectrum.

Figure 53. EDS spectrum of the corrosion product on the fracture surface.

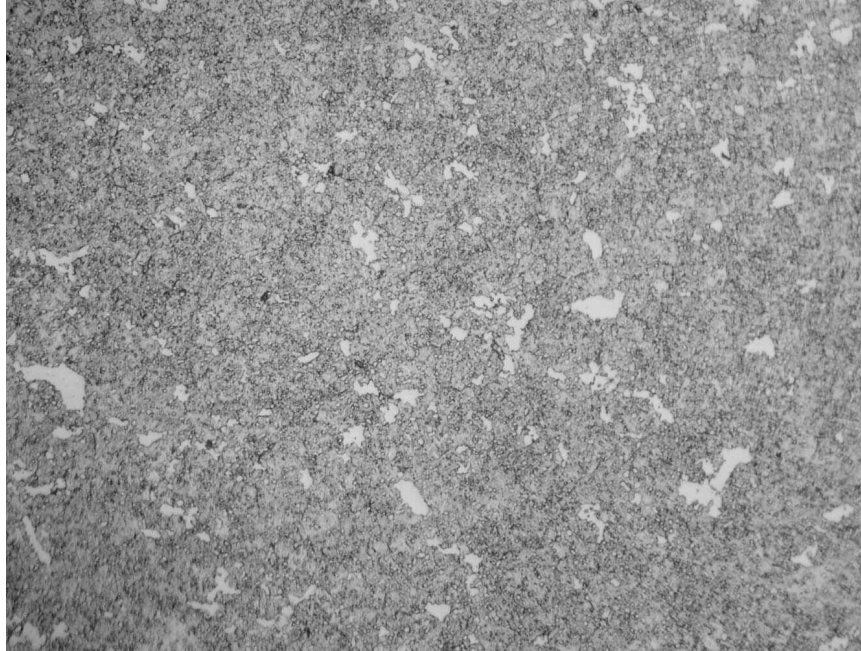
It was speculated that this component was perhaps sensitized during production because of the presence of inter-granular attack at the surface. Specification HP 1-1 summarizes a laboratory test that was used by ARL to determine whether the component had been sensitized. Paragraph 3.3.2.5 states that type B steels (type 440C) shall be metallographically prepared and etched for 1 to 2 minutes in a freshly prepared solution consisting of 1 gram of picric acid, 5 ml of hydrochloric acid, and 100 ml ethanol. Paragraph 2.1.1.4 indicates that components with ultimate tensile strength greater than 220 ksi shall not exhibit inter-granular attack greater than 0.0005 inch in depth. The sample showed negligible evidence of inter-granular attack as a result of this test (see figure 54), which did not exceed the depth requirement. In addition to the metallographic sample, ARL subjected a piece of the actual component in the as-received condition to the etchant. Photographs were taken before and after the application of the etchant (figures 55 through 58, respectively) on both the as-received surface and a machine cut surface. There was no evidence of inter-granular attack on any of these surfaces.

Figure 54. Structure of type 440C steel after sensitization testing (negligible inter-granular attack was noted as a result of this testing) (mag. 400x).

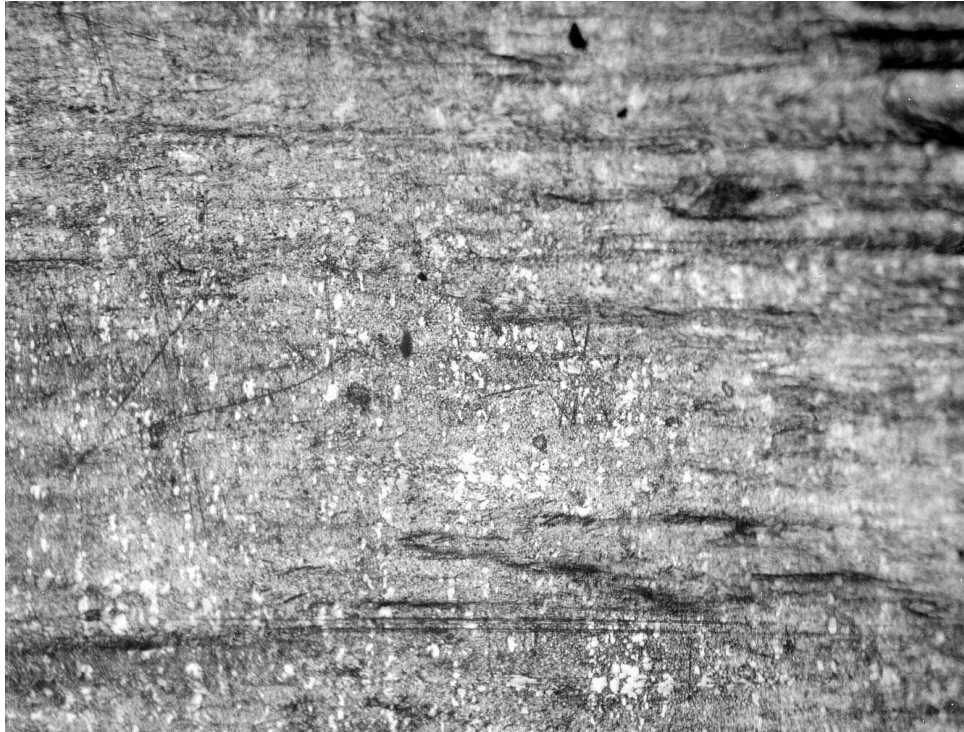
Figure 56. Macrograph of as-received surface of rod end fitting ball subjected to sensitization testing (no inter-granular attack was noted) (mag. 100x).

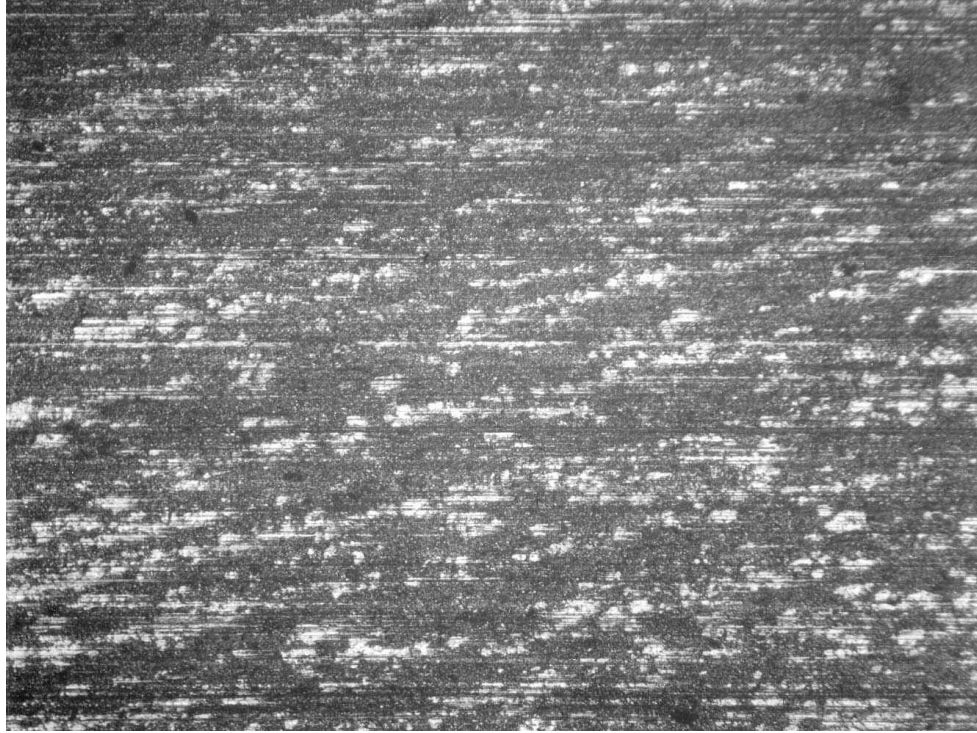
Figure 58. Macrograph of the machined surface of rod end fitting ball subjected to sensitization testing (no inter-granular attack was noted (mag. 100x).
